DEPARTMENT OF TRANSPORTATION

Contract #: 04-0120F4Cty: SF/ALA Rte: 80 PM: 13.2/13.9File #: 69.28**WELDING INSPECTION REPORT****Resident Engineer:** Pursell, Gary**Address:** 333 Burma Road**City:** Oakland, CA 94607**Report No:** WIR-012065**Date Inspected:** 05-Feb-2010**Project Name:** SAS Superstructure**OSM Arrival Time:** 700**Prime Contractor:** American Bridge/Fluor Enterprises, a JV**OSM Departure Time:** 1900**Contractor:** Zhenhua Port Machinery Company, Ltd (ZPMC), Changxing Island **Location:** Shanghai, China

WELDING INSPECTION REPORT

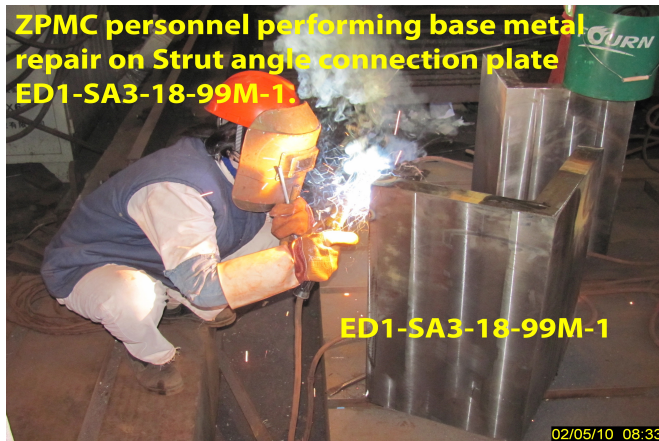
TOWER STRUT ANGLE CONNECTION PLATE (T-CWR561, REV. 0)

During random in process verification, this QA Inspector observed that SMAW welding on the base metal of ED1-SA3-18-99M-1 of Tower Strut Angle Connection plate. Welder is identified as 040268. ZPMC QC is identified as Mr. Yu Zhi Lai. The welding variables recorded by QC appeared to comply with WPS-485-SMAW-2G(2F)-FCM-REPAIR-1. Attached photographs provide additional details.
